Manhole Inspection Summary

Manhole # **S17C__011MH**

Location Address: **REAR OF 2515 EDMONSON AVE** Cross Street: **WARWICK AVE**

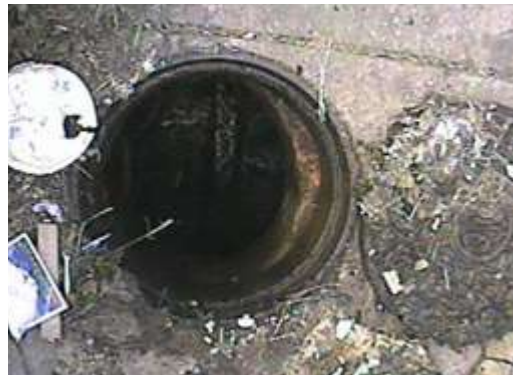
Defect 2

Frame Offset: **3** (in.) Condition: ☒ Sound ☐ Cracked ☐ Leaks

FRAME OFFSET

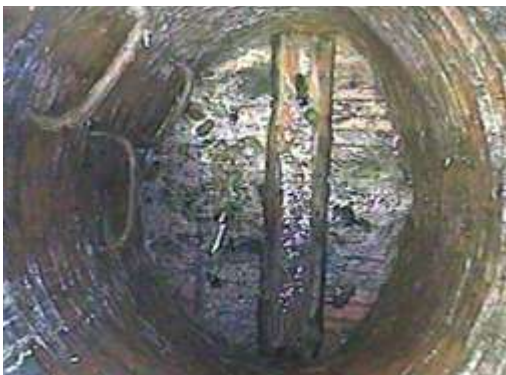
Defect 1

Steps Count: **4** Missing: **0** ☒ **Corroded**

CORRODED STEPS

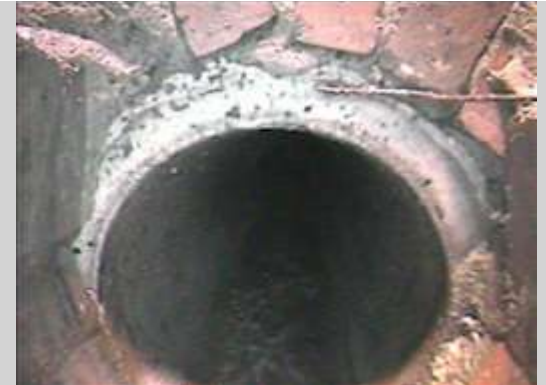
12 O'Clock Outflow

8 in. Circular Gravity Sewer
Pipe Out @ 12 O'Clock

Pipe Material: **Clay** ☐ Pipe Lined

Invert Depth: **7.94** (ft.) Flow Characteristics: **Slow**

Infiltration: **None** Pipe Seal Cond: **Sound**

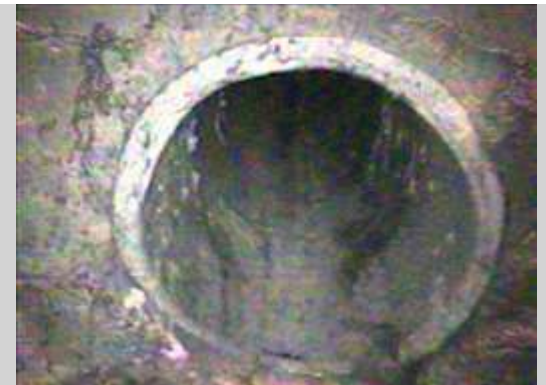
3 O'Clock Inflow

Comments **HOUSE CONNECTIONS@ 3 AND 9 O'CLOCK HAVE NO CHANNEL**

8 in. Circular Gravity Sewer
Pipe In @ 3 O'Clock

Pipe Material: **Clay** ☐ Pipe Lined

Invert Depth: **7.15** (ft.) Flow Characteristics: **None**

Infiltration: **None** Pipe Seal Cond: **Sound**

Connects To: **House connection / Service line**

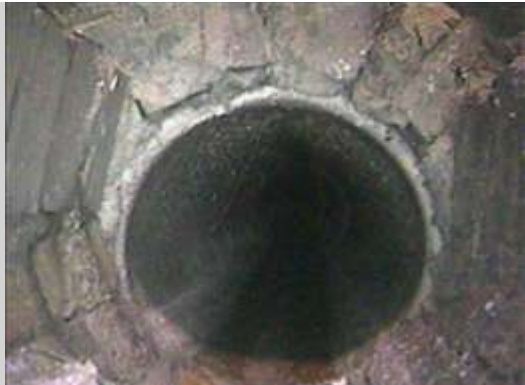
6 O'Clock Inflow

8 in. Circular Gravity Sewer

Pipe In @ 6 O'Clock

Pipe Material: **Clay** ☐ Pipe Lined

Invert Depth: **7.90** (ft.) Flow Characteristics: **Slow**

Infiltration: **None** Pipe Seal Cond: **Sound**

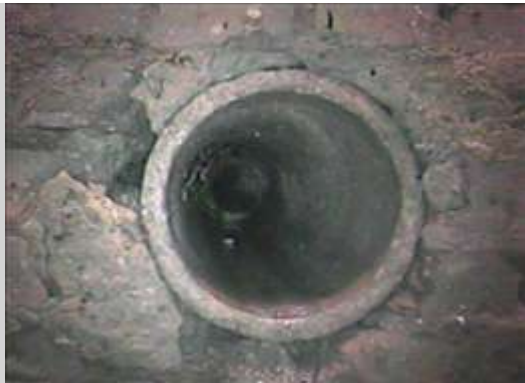
9 O'Clock Inflow

6 in. Circular Gravity Sewer

Pipe In @ 9 O'Clock

Pipe Material: **Clay** ☐ Pipe Lined

Invert Depth: **7.21** (ft.) Flow Characteristics: **None**

Infiltration: **None** Pipe Seal Cond: **Sound**

Connects To: **House connection / Service line**
